# Manhole Inspection Summary

Manhole # S17GG2018MH

Insp Date: **10/9/06 1:26 PM**

**Location** Address: **5920 SMITH AVE**

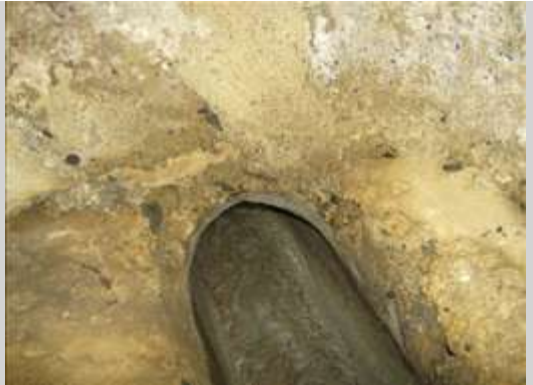
### 8 in. Circular Gravity Sewer Pipe Out @ 12 O'Clock

Pipe Material: **Clay** ☐ Pipe Lined

Invert Depth: **6.29** (ft.) Flow Characteristics: **Slow**

Deposits: ☒ None ☐ Mud ☐ Sludge ☐ Debris ☐ Grease

Infiltration: **None** Pipe Seal Cond: **Unknown**

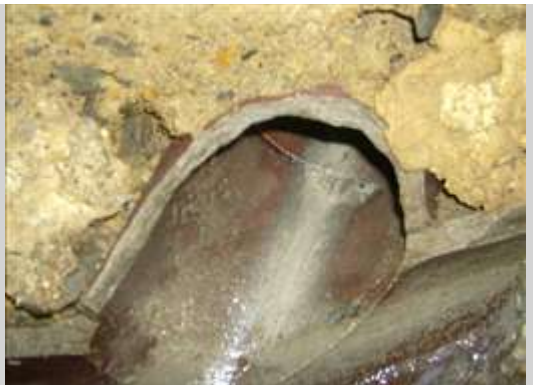
### 6 in. Circular Gravity Sewer Pipe In @ 3 O'Clock

Pipe Material: **Clay** ☐ Pipe Lined

Infiltration: **None** Pipe Seal Cond: **Unknown**
